Mitchell Show Dome Condition Assessment

Pierce Engineers (PE) Restoration Structural Engineers, and a team of sub-consultants / contractor performed materials testing on the precast concrete frame and a foundation condition assessment of the Show Dome at the Mitchell Park Horticultural Conservatory, Milwaukee, Wi. The assessment work was performed in 2019.

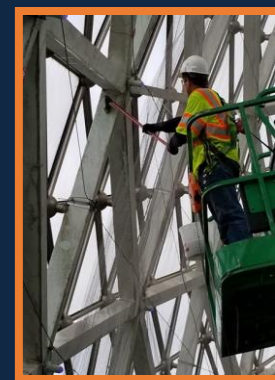
Corrosion Potential Testing

VCS performed a corrosion and material evaluation of the concrete frame while NDT Corporation conducted a non-destructive evaluation of the concrete elements. The focus of the evaluation was to identify the extent of concrete deterioration that cannot be observed through tactile inspection alone. This includes corrosion activity, concrete degradation, concrete strength, condition of grout pockets, and weld plates. Testing included the following: Ground penetrating radar (GPR), Electrical continuity, Corrosion Potential Survey, Sonic/Ultrasonic Measurements, Concrete Material Sampling testing for chloride and carbonation, along with exposing two joint locations by grout removal. Sampling locations were selected by team to represent the varied conditions of the precast concrete frame.
